# Town of Buena Vista

## Architectural Design Guidelines

## Historic East Main

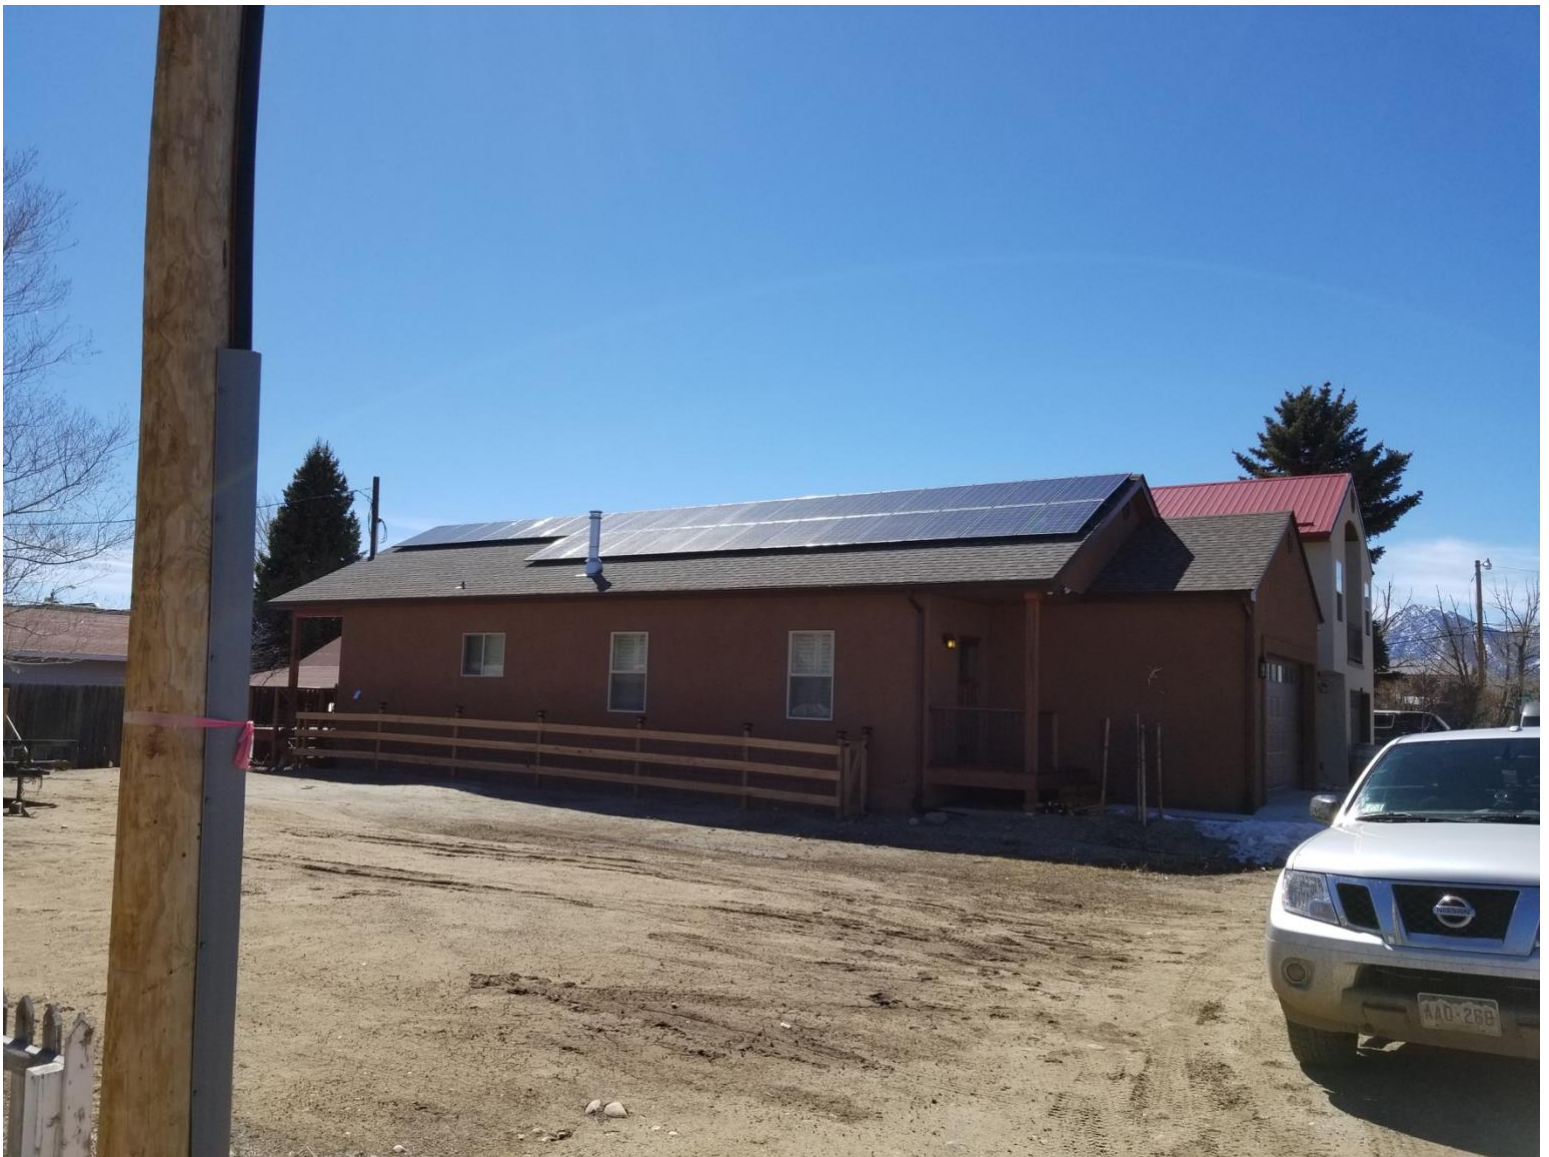
*Figure 3.1 Example of an acceptable solar installation on a gable roof*

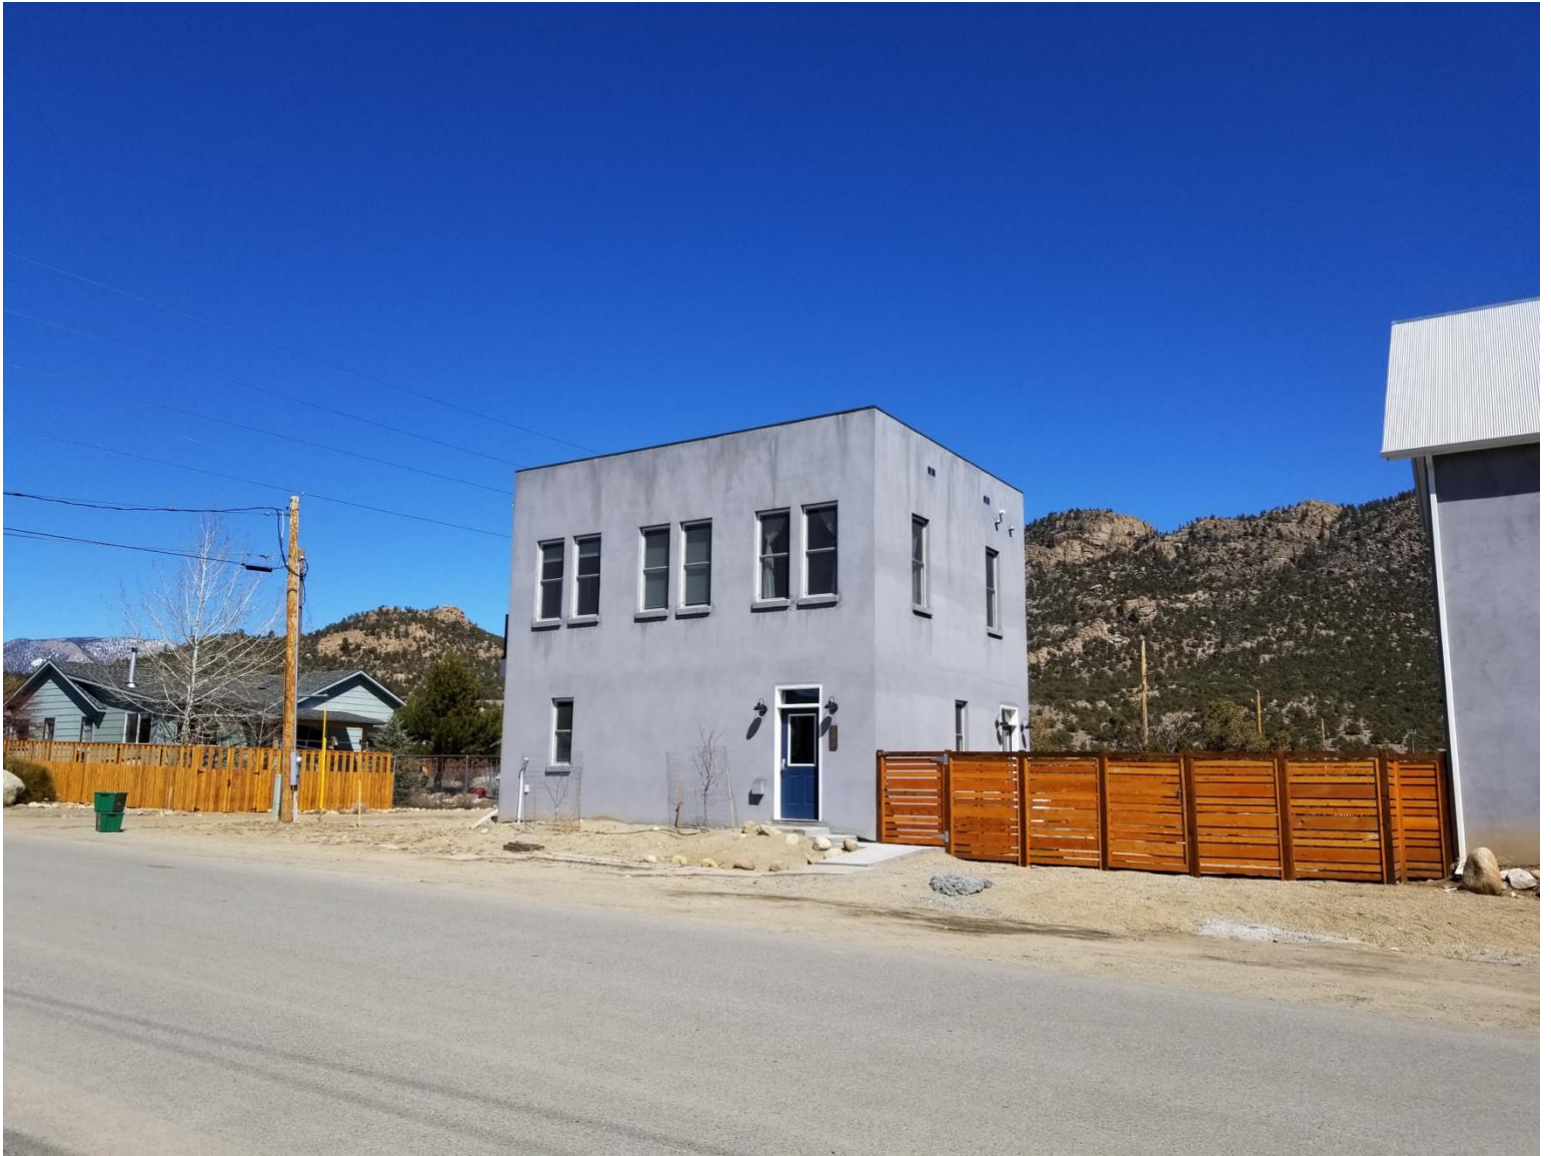
*Figure 3.2 Solar Installation on Flat Roof; Note that no portion of the installation is visible above the roofline when viewed from across the street*

On the primary street frontage, the solar panels should not be mounted in such a manner that they are visible from a point six feet above the curb opposite the primary street frontage. On corner lots the primary street frontage visibility requirement will apply to both streets.

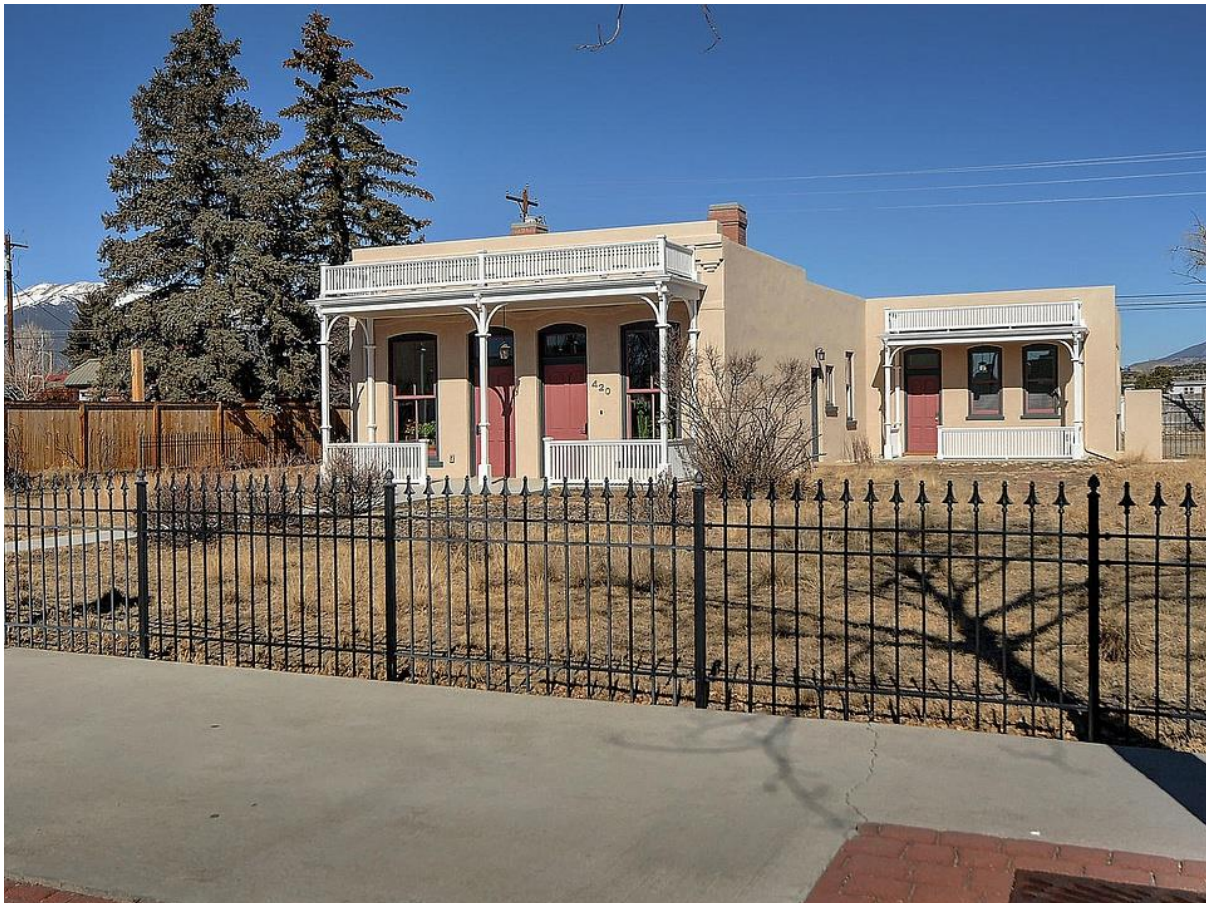
*Figure 3.4 Example of acceptable landscaping incorporating the use of native grasses*

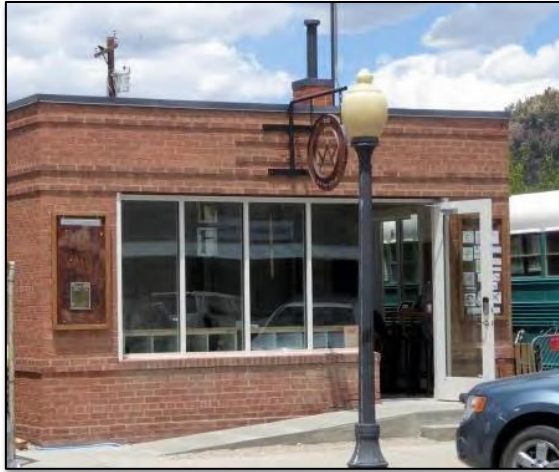
*Figure 4.2 Example of remodeling that returned the subject structure to a “contributing” status; In this context, “contributing” meaning that the structure has sufficient historic accuracy to qualify for landmark status and/or otherwise contribute to a potential historic district.*

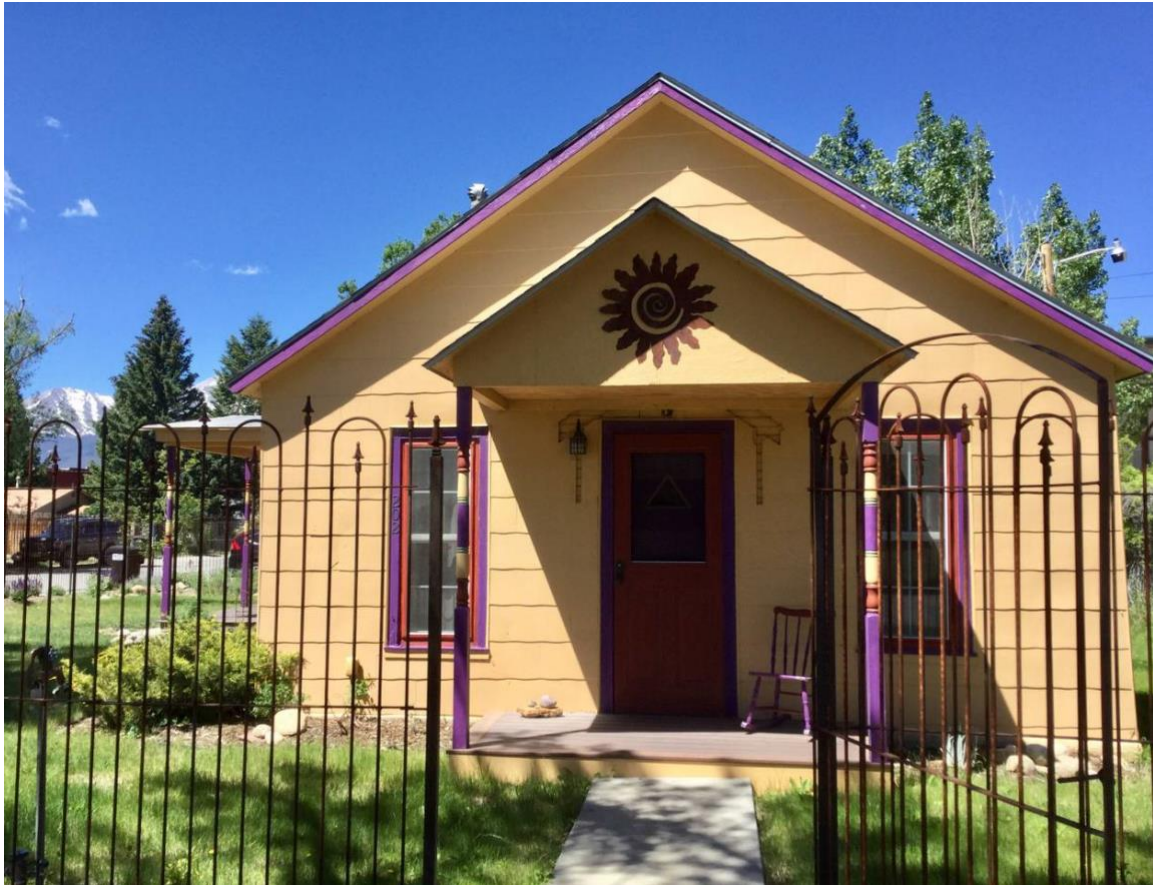
*Figure 4.4 Replacement materials should be similar in character to those used historically. This is an inappropriate use of materials. This building has asbestos siding installed over the original wood, lap siding.*

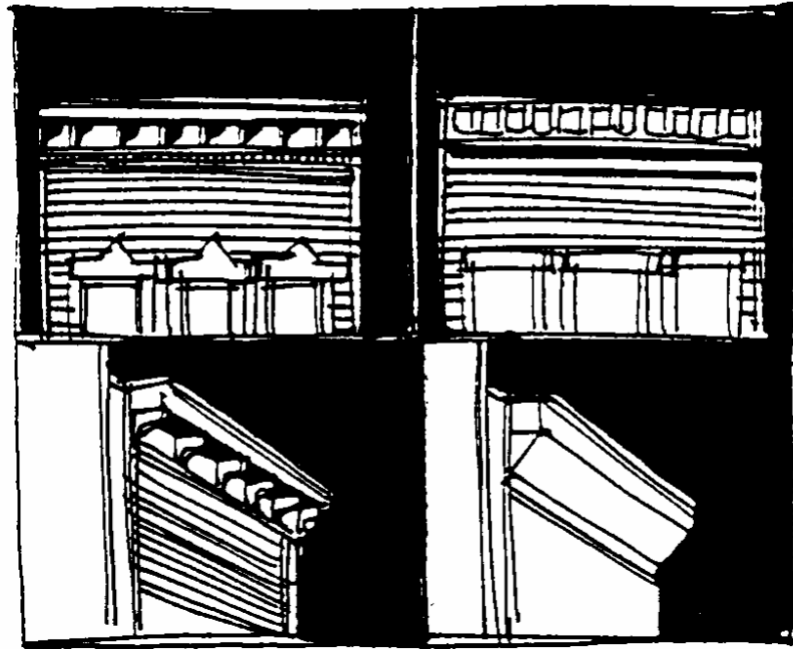
*Figure 4.5 When reconstruction of an element is impossible, developing a compatible new design that is a simplified interpretation of the original is appropriate*

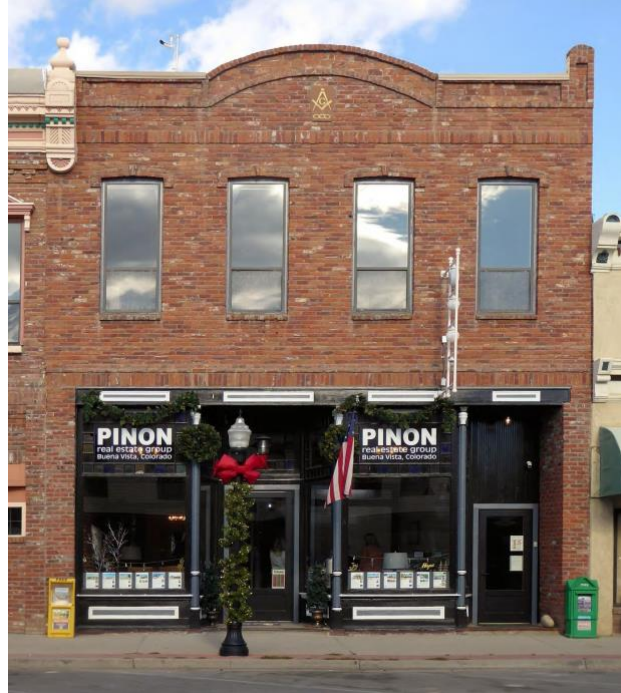
*Figure 4.9 Maintain recessed entries with kick plate below windows and transom above; Reestablish where missing*

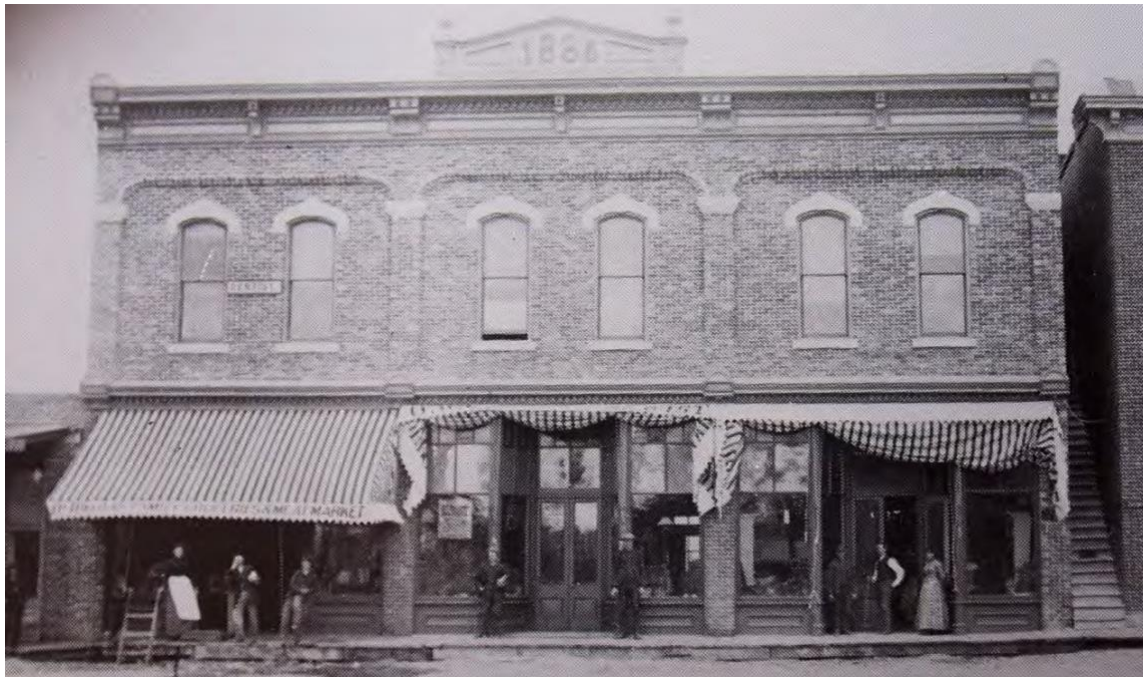
*Figure 4.10 Example of Historically Accurate Awnings*

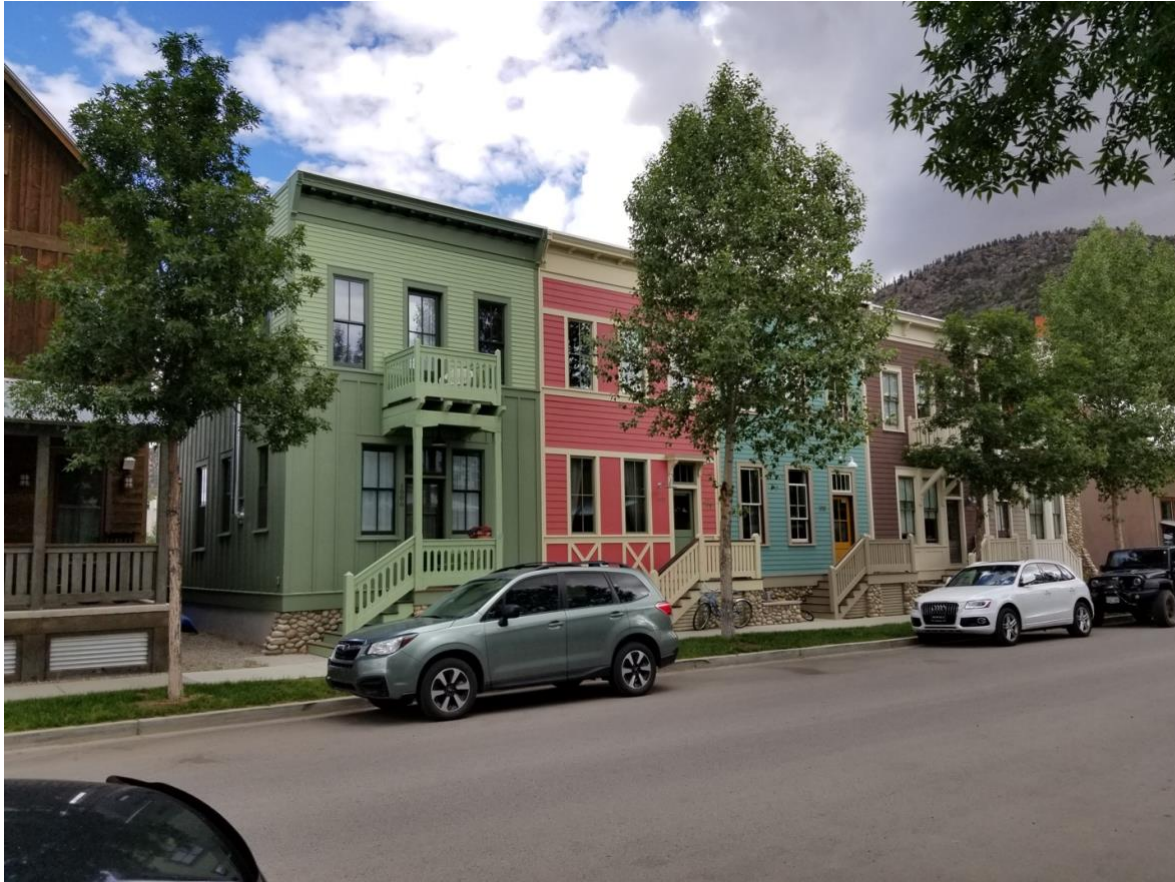
*Figure 5.X Example of a divided structure*

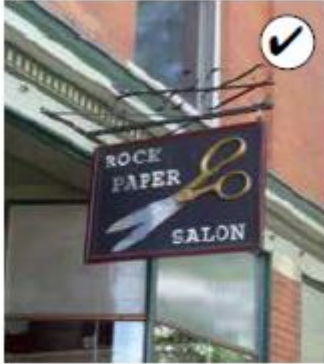
*Locate a small projecting sign near the business entrance, just above or to the side of the door.*

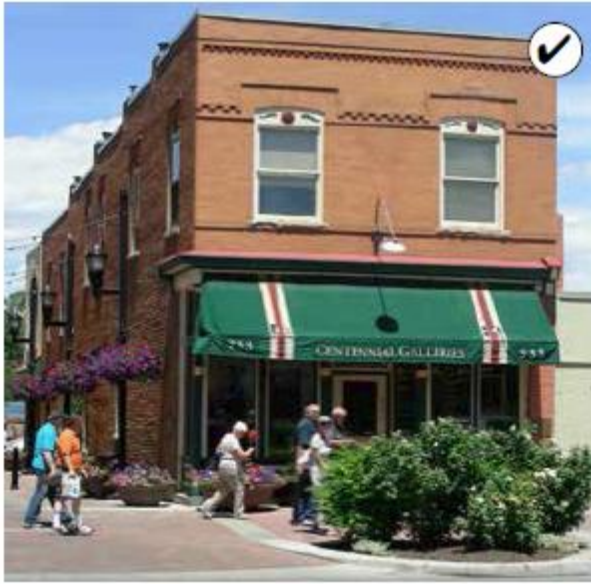
*An awning sign shall be compatible with the building.*

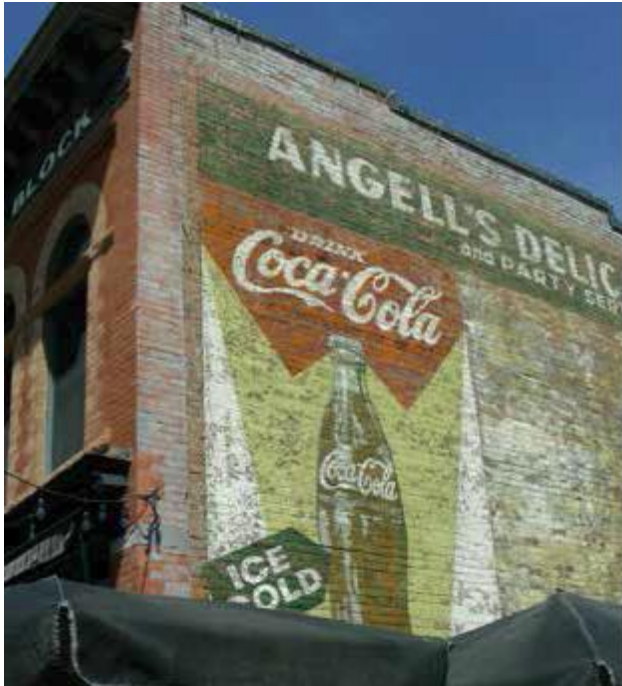
Leave a historic sign visible

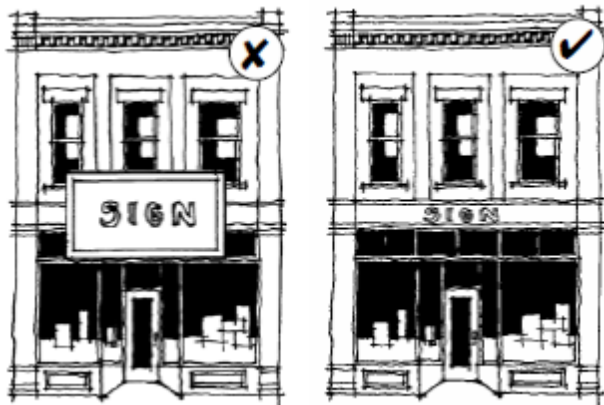
*Mount a sign to fit within existing architectural features using the shape of the sign to help reinforce the horizontal lines of the building.*
